Matt Anderson, PhD
Xu Li, PhD
University of Nebraska Lincoln

HUMAN PATHOGENS IN THE GREENHOUSE?!

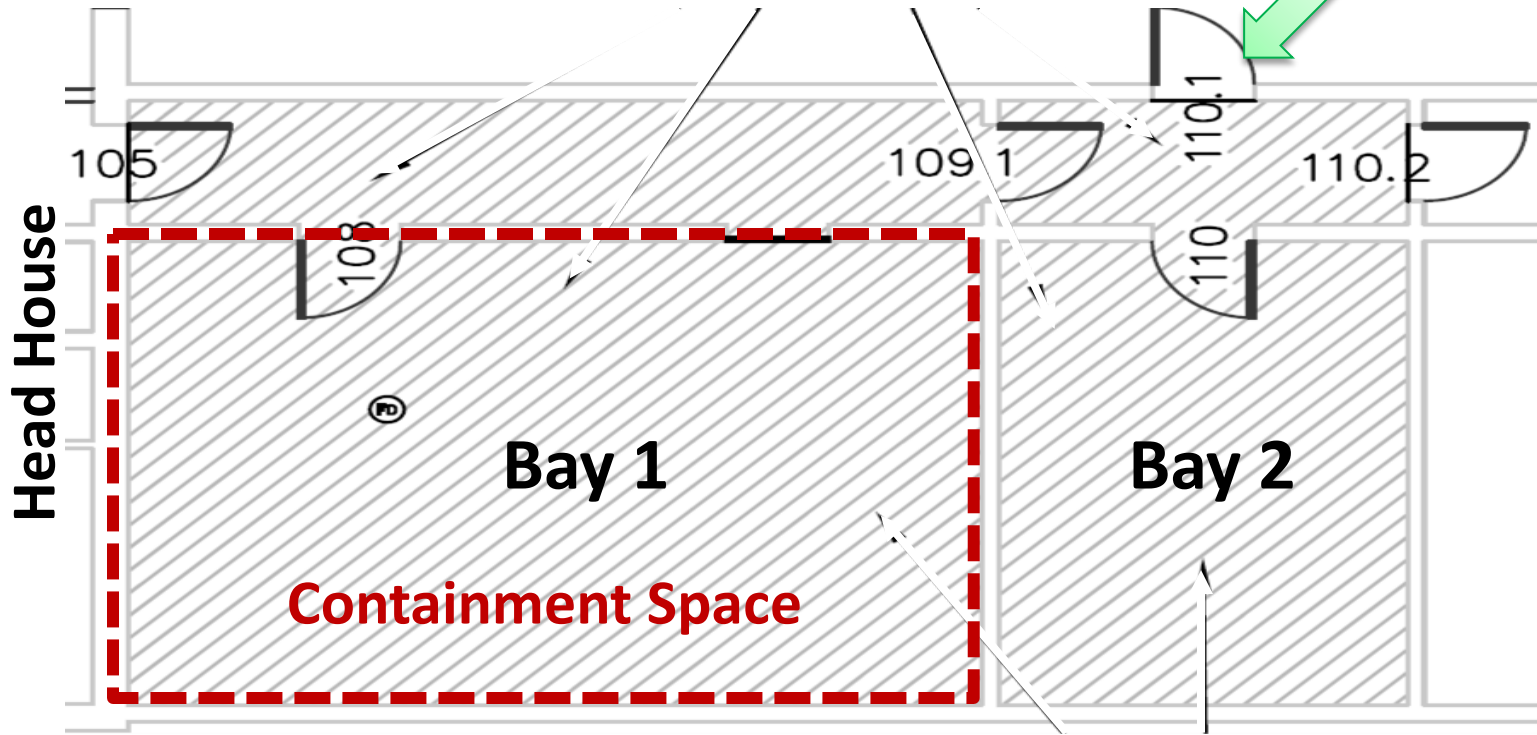
New Floor Plan

Outside Entry Door

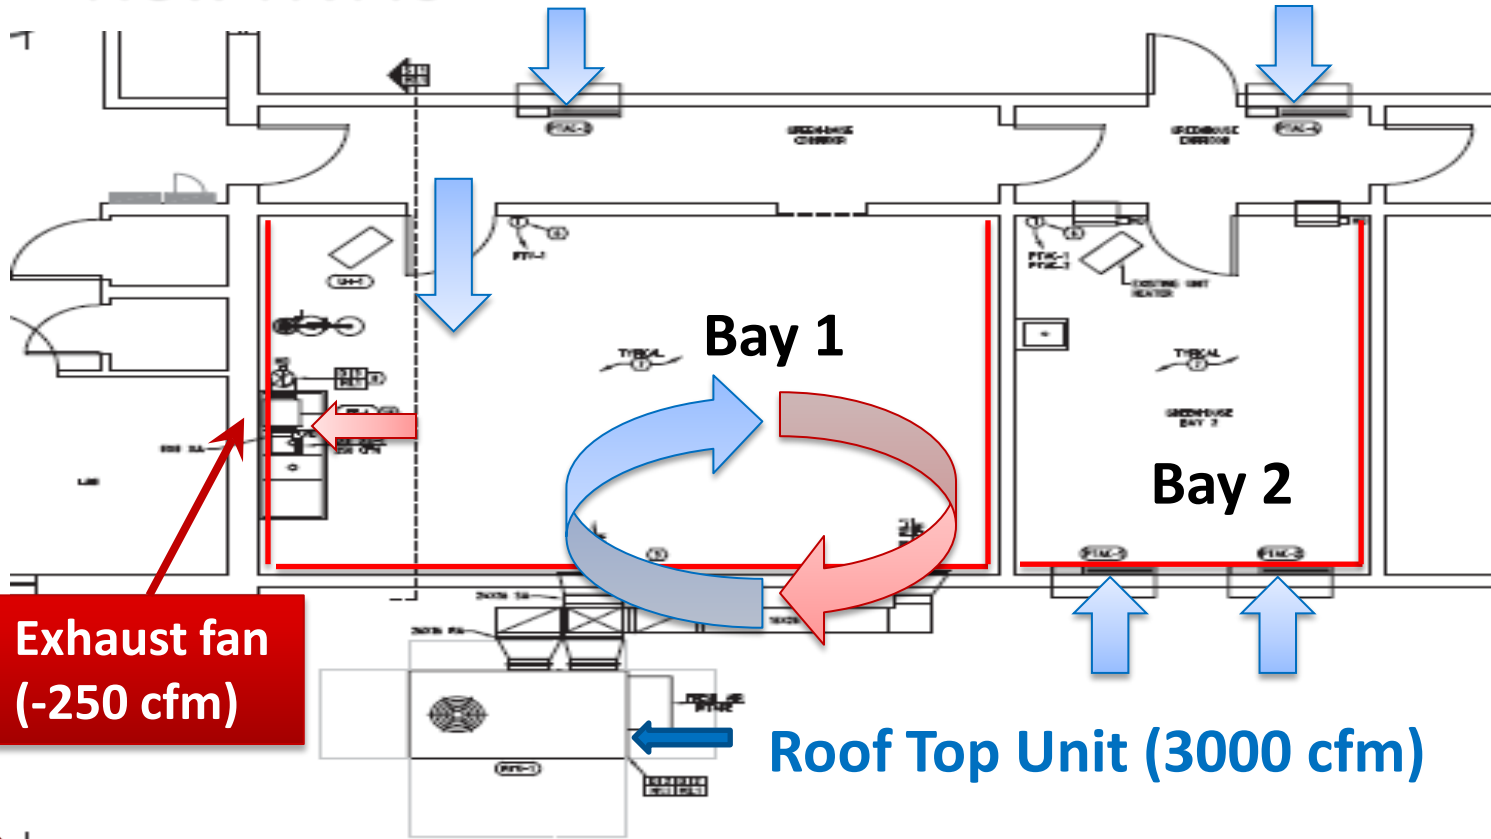
New HVAC

← Supply ← Exhaust

**Exhaust fan
(-250 cfm)**

Roof Top Unit (3000 cfm)

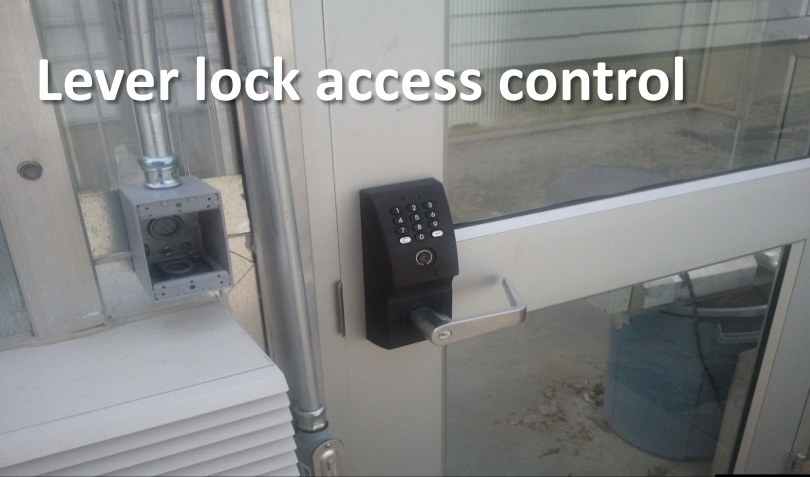
Lever lock access control

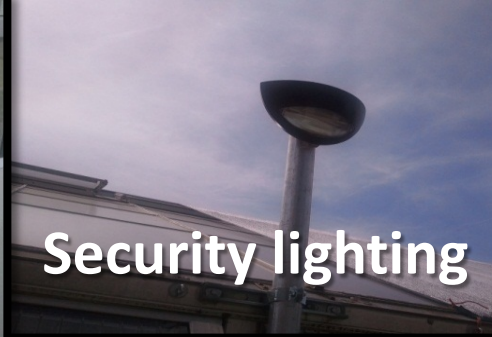
Security lighting

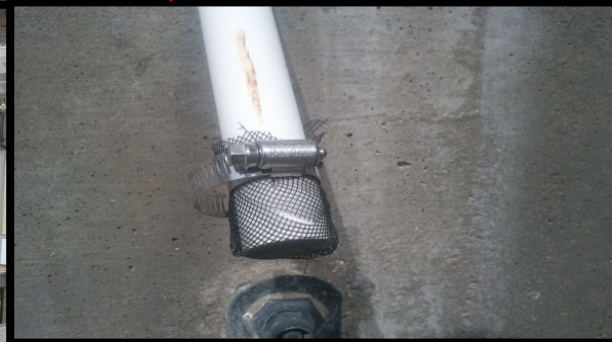
Insect netting on
roof drain tubes

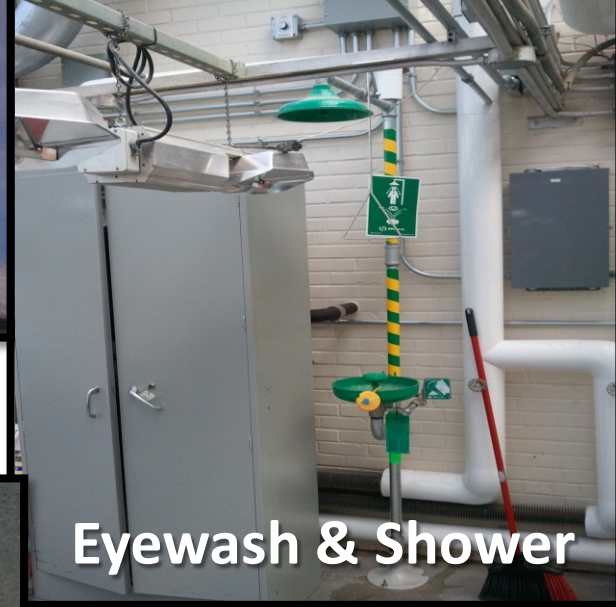
Eyewash & Shower

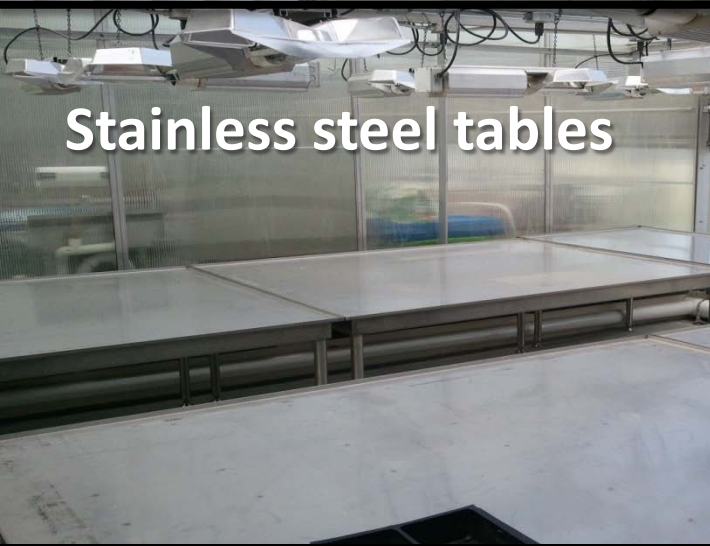
Stainless steel tables

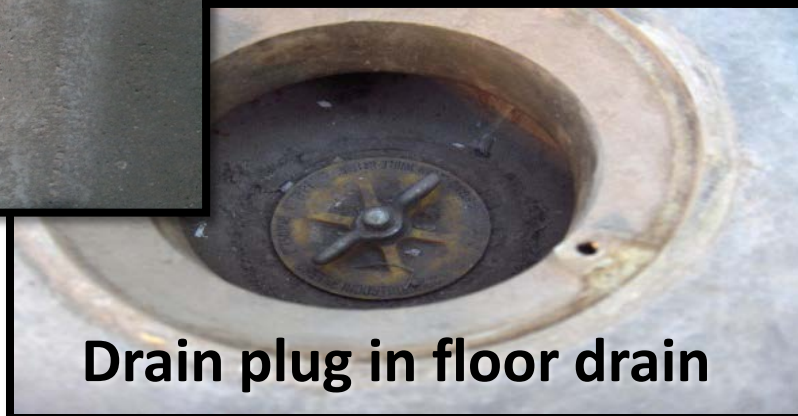
Drain plug in floor drain

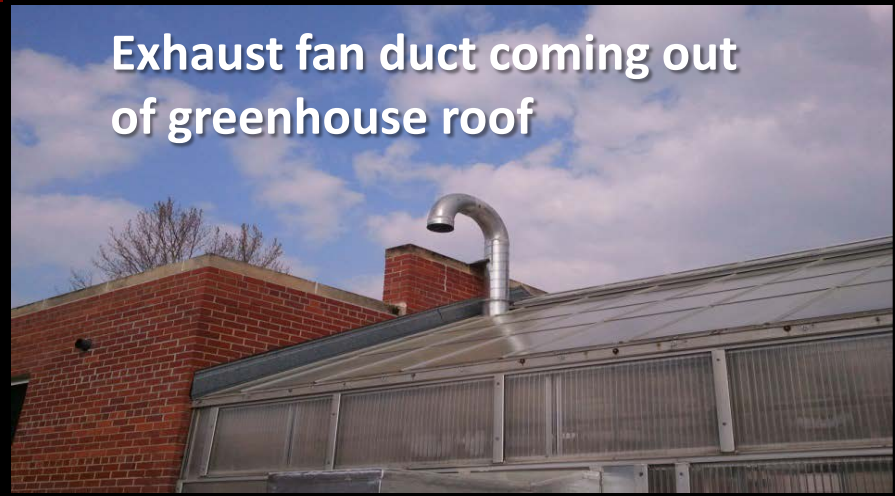
Exhaust fan
