# WHY DID THE SALMONELLA-SPIKED CHICKEN CROSS THE AUGER?

*Adventures in Interdisciplinary Research Risk Assessment*

Shane Gillooly

Assistant Biosafety Officer  
Environmental Health & Safety  
Georgia Institute of Technology

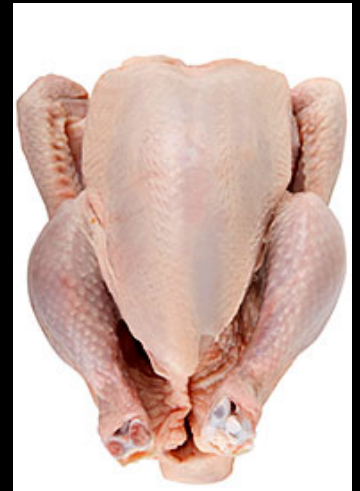
We found that the project was well beyond the “norm” for campus:

- Whole chicken carcasses
- An environmental chamber in the middle of a high bay warehouse
- Trash can with aquarium heaters as the “incubator”
- 12’ long food processing auger as the “water bath”
- Industrial sized slurry machine
- Antibiotic-resistant strain of *Salmonella*
- PI’s 1<sup>st</sup> project working with microorganisms

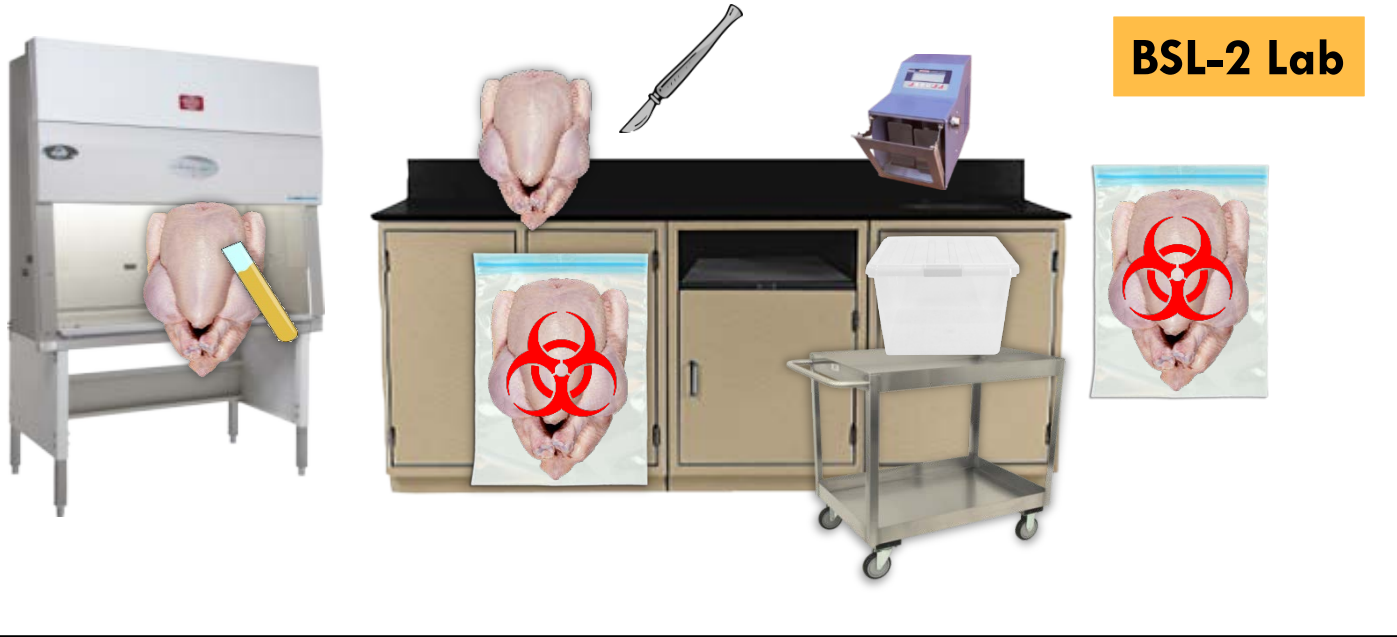
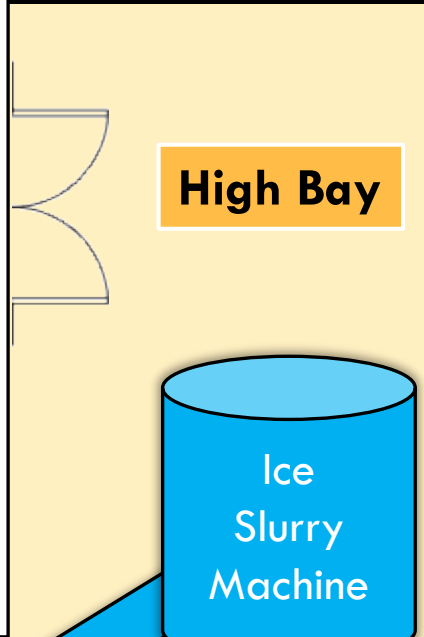
# INITIAL PROJECT PLAN

1. Inoculate whole chicken carcasses in BSC of BSL-2 lab with *Salmonella*; place in plastic bags
2. Cart chickens to environmental chamber through high bay
3. Add chickens to trash can sized incubator for overnight incubation
4. Add chickens to chlorinated ice bath in auger after removing them from bags:
  1. Ice slurry (from slurry machine in high bay)
  2. Traditional ice bath (getting ice from cafeterias & sports medicine areas on campus)
5. Run the auger (moving parts, water jets, no lid or containment)
6. Remove chickens from the bath and cart back to the BSL-2 lab
7. Isolation of tissue on open bench, then place in stomacher on open bench

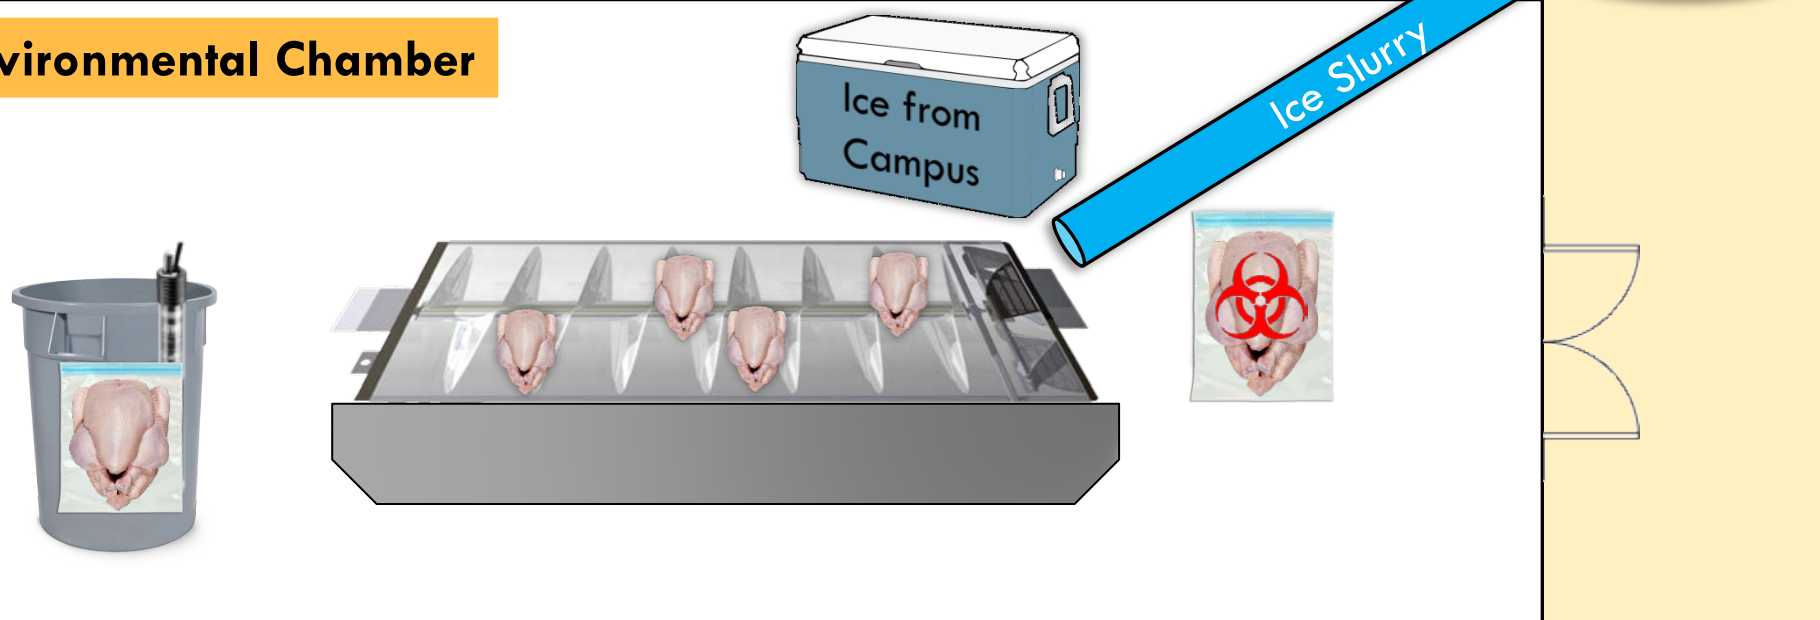
## Environmental Chamber

- Use of the environmental room
  - No sink, eyewash, safety shower
  - Suspicious of lab ventilation
- Use of antibiotic resistant strain
- Transport of materials between BSL-2 lab and environmental room
- Use of ice from campus food service and sports medicine areas
- Lack of primary containment during use of auger
- Aerosols generated by the auger
- Messy slippery process around the auger during loading and unloading

- The environmental room has no ventilation
  - Needs renovation or new location for project
- Auger's moving parts exposed
  - Has emergency stop but no signage
- Electrical safety issues with the trashcan incubator
- High potential for slips, trips and falls
  - Can procedure modification and slip resistant boots help reduce the risk?

- No funding or time available to renovate the environmental chamber, so auger was moved to BSL-2 lab
- Revised SOPs to address electrical safety and slips, trips and falls issues
- Biosafety still felt that the lack of containment while the chicken was in the auger was a problem but was having trouble getting the PI to change project design

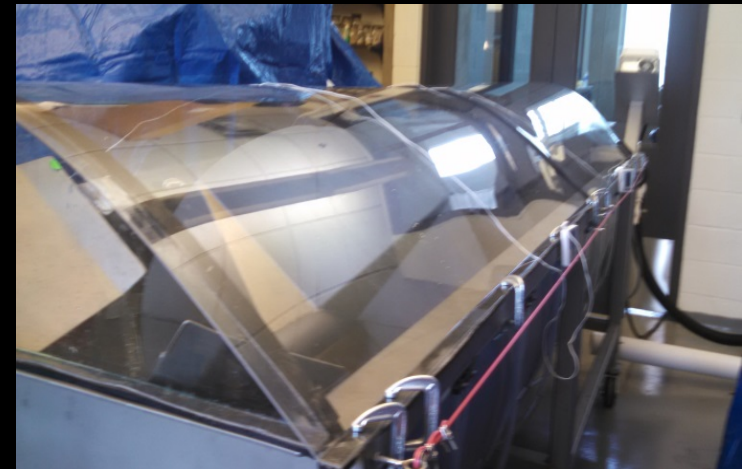
# LID DESIGN

After a few trials and errors, the lab was able to design and manufacture and plastic lid for the auger:

- Sealed around the top of the auger
- One end included a HEPA filter
- Other end had a window that could be opened to add and remove chicken carcasses

SOPs were written for use of the lid:

- Seal testing
- Decontamination of HEPA filter, auger and lid
- Operation of the window and auger jets

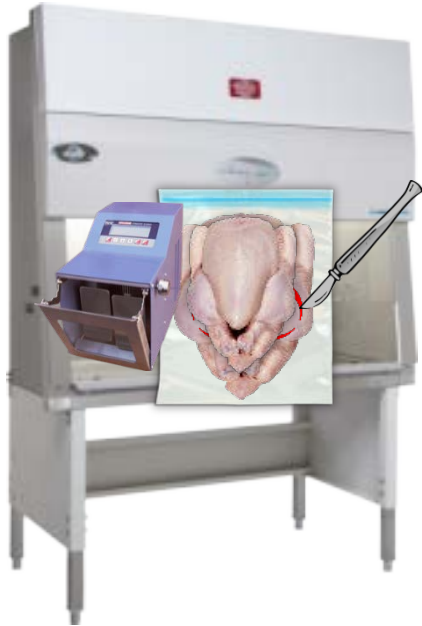
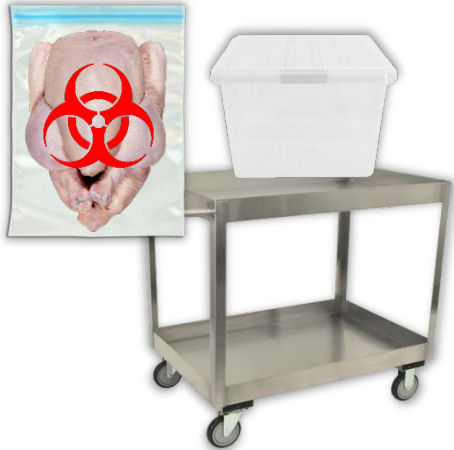
# FINAL PROJECT PLAN

**BSL-2 Lab**

**High Bay**
