IMPLEMENTING THE REQUIREMENTS FOR THE BIOSAFETY LEVEL III FACILITY AT THE ARC-ONDERSTEPSPOORT VETERINARY INSTITUTE

Bontsi Mochotlhoane

ARC – Agricultural Research Council
OVI- Onderstepoort Veterinary Institute
South Africa

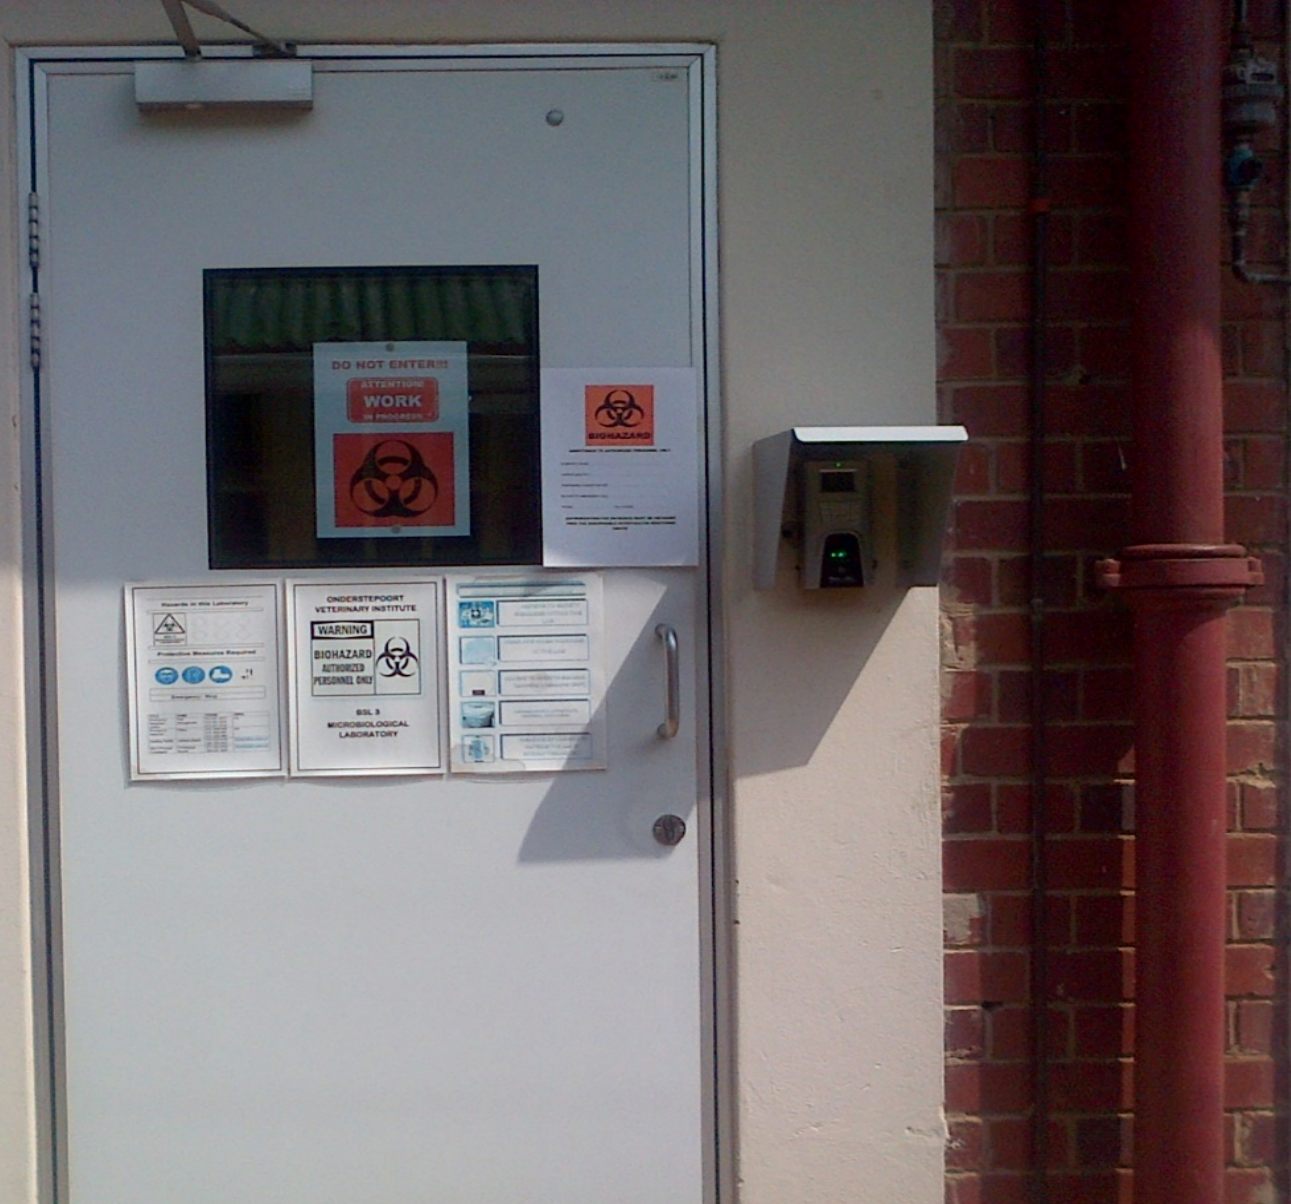
Engineering – Building Design

Front entrance

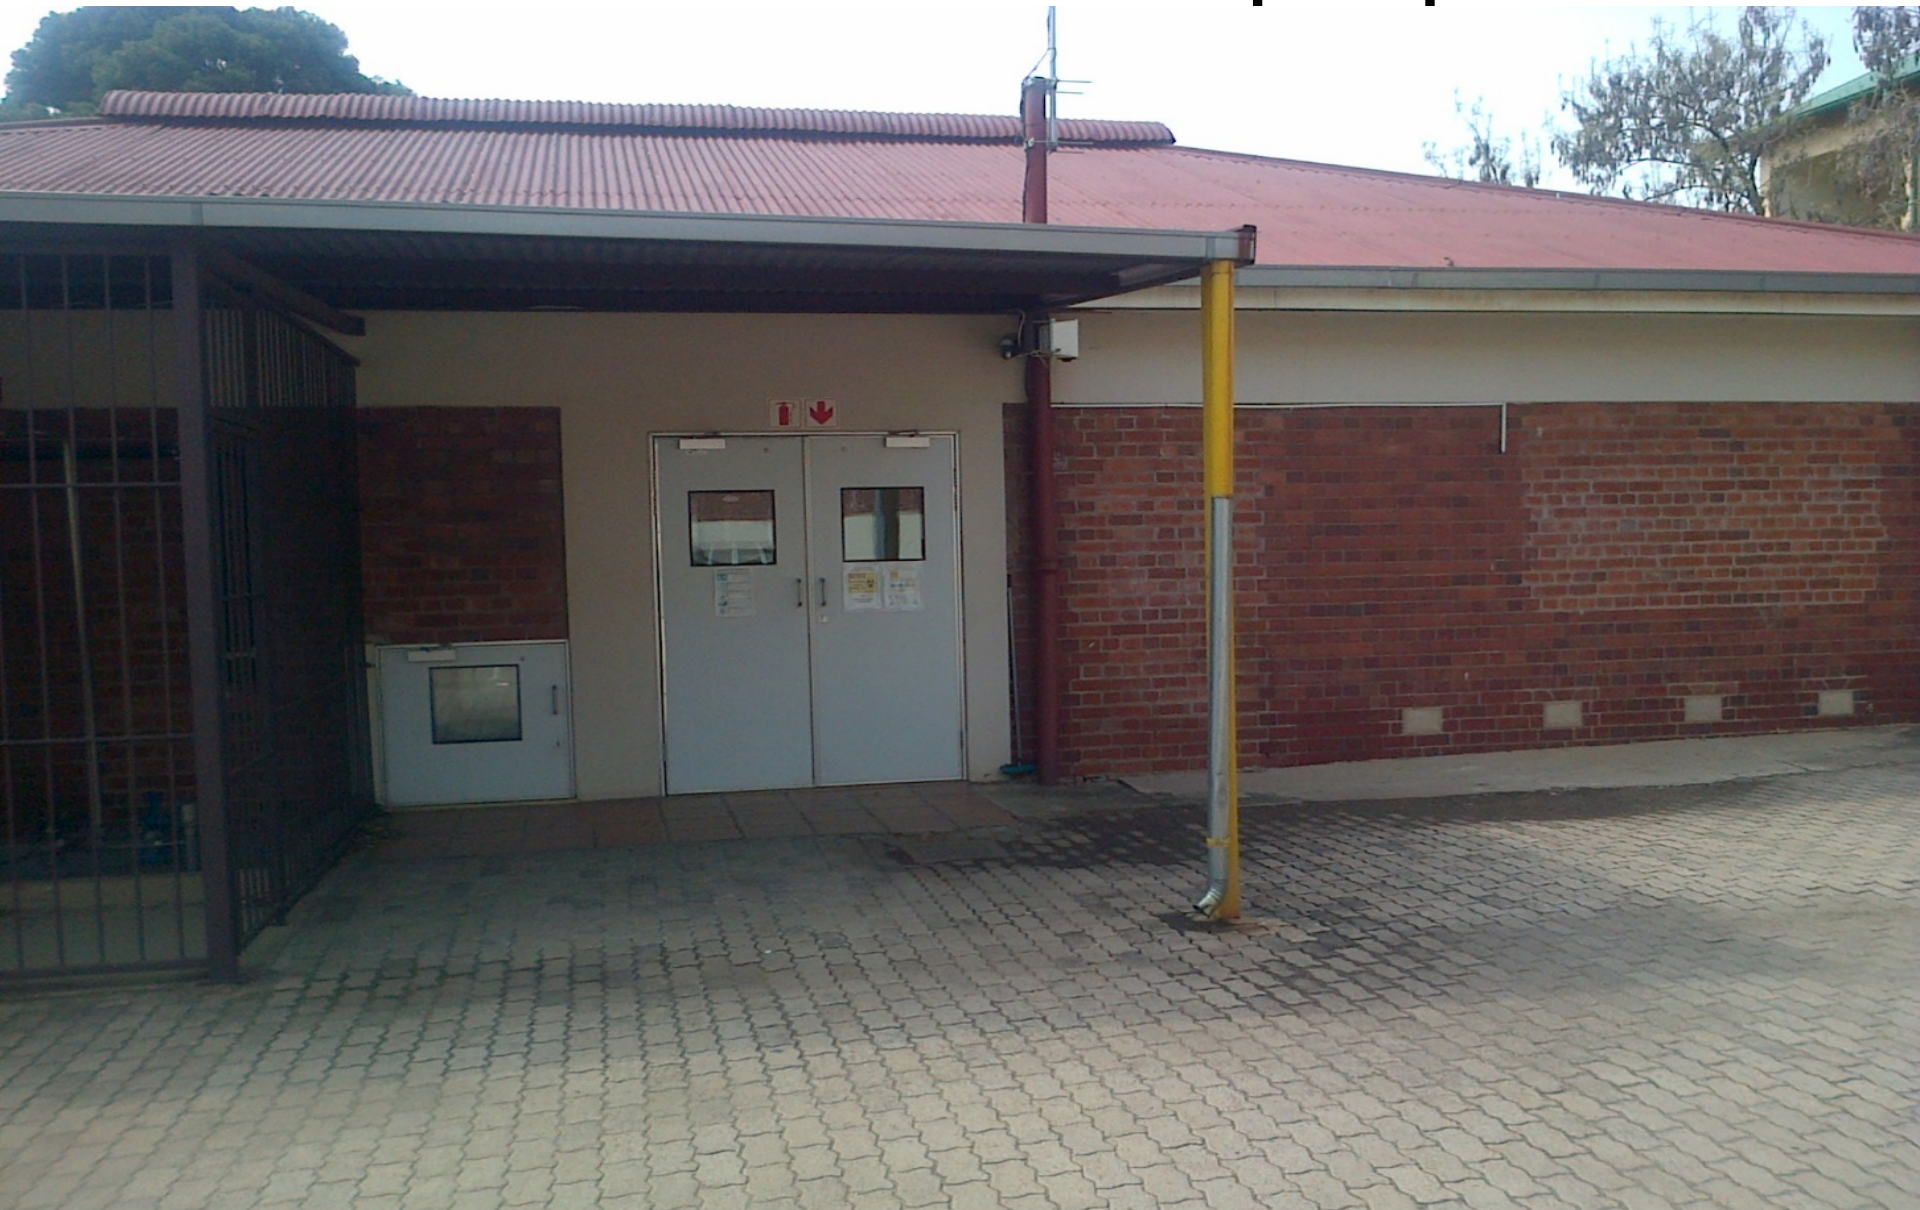
Engineering – Building Design

Back door with sample port

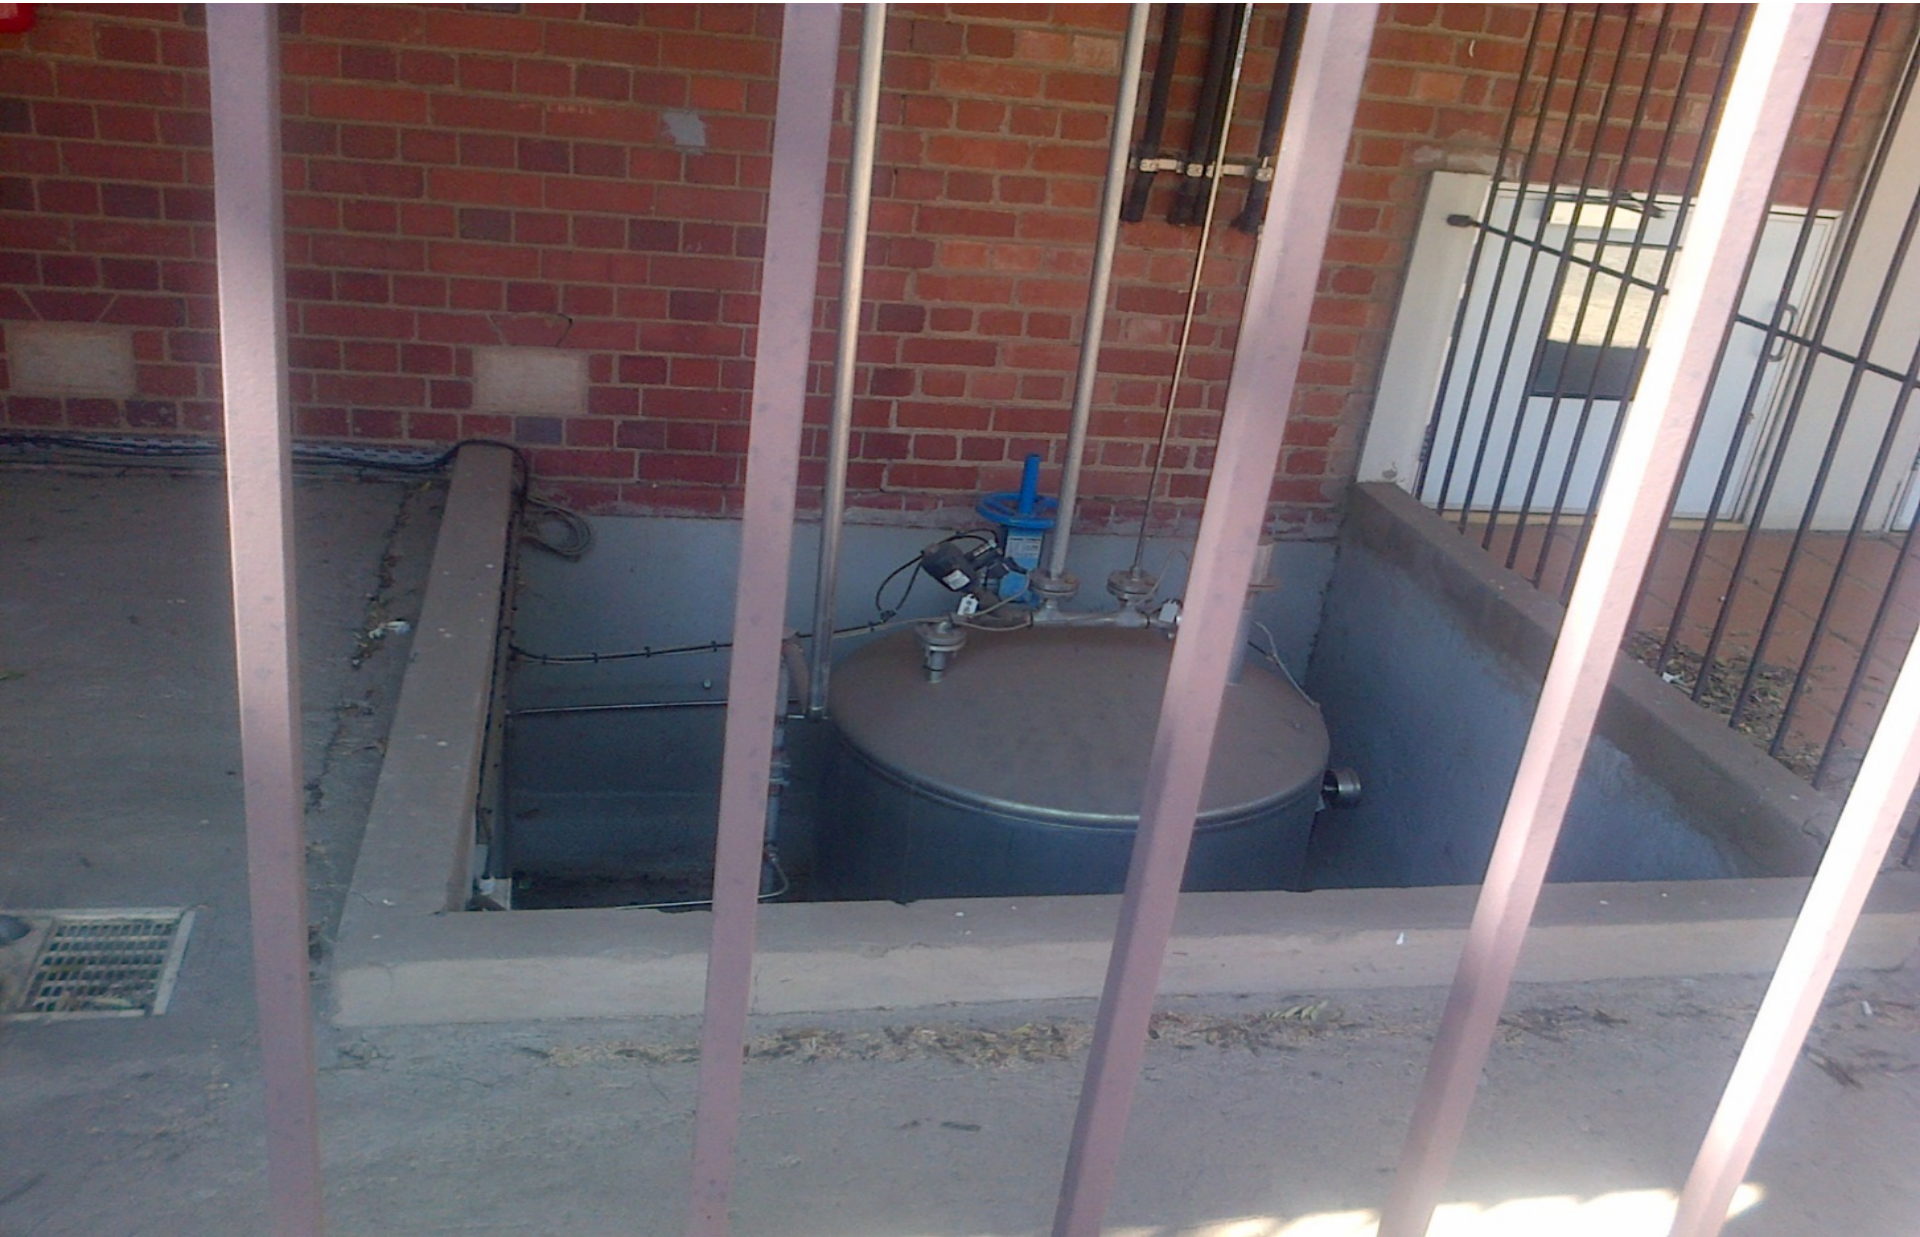
Engineering – ETS tank

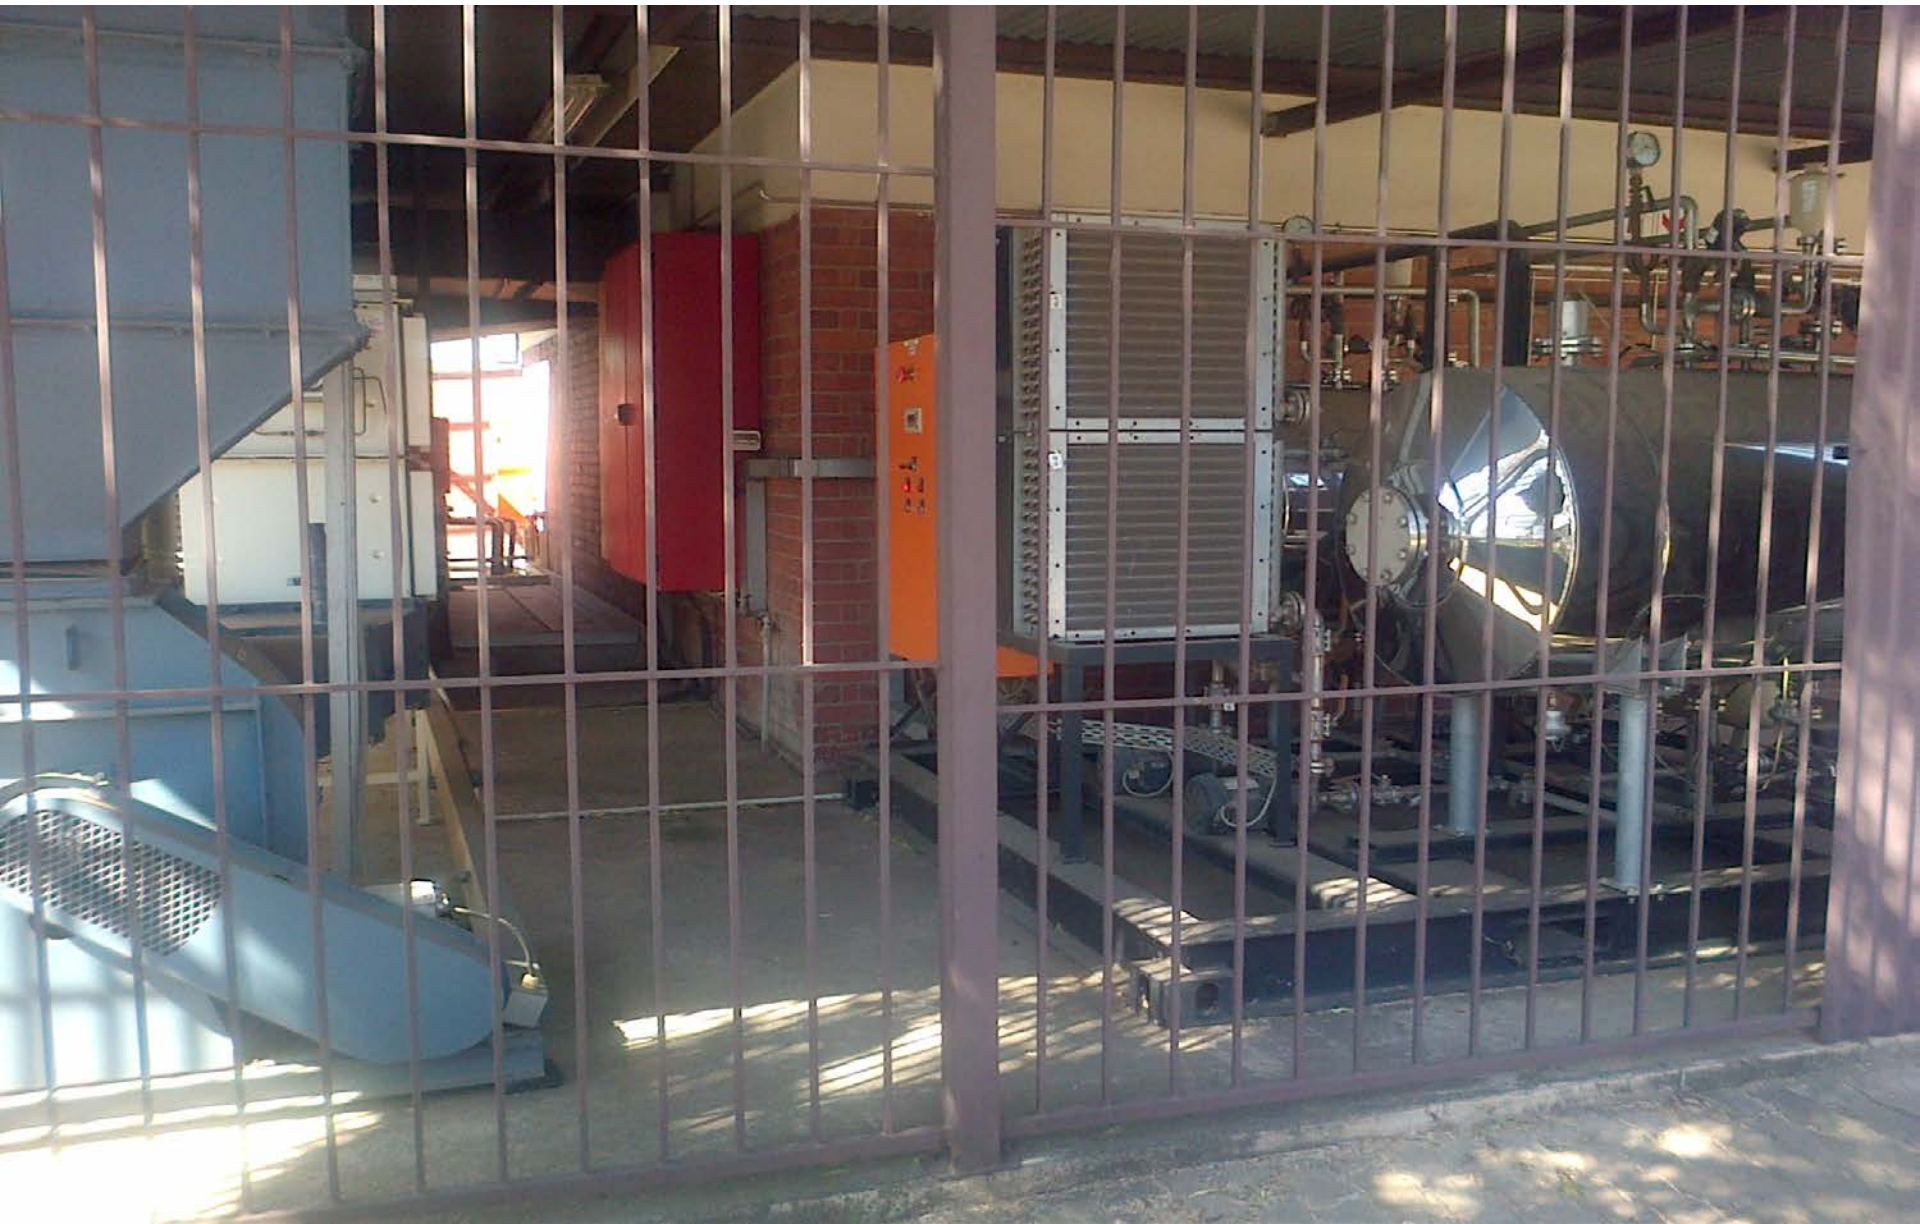
Engineering – ETS

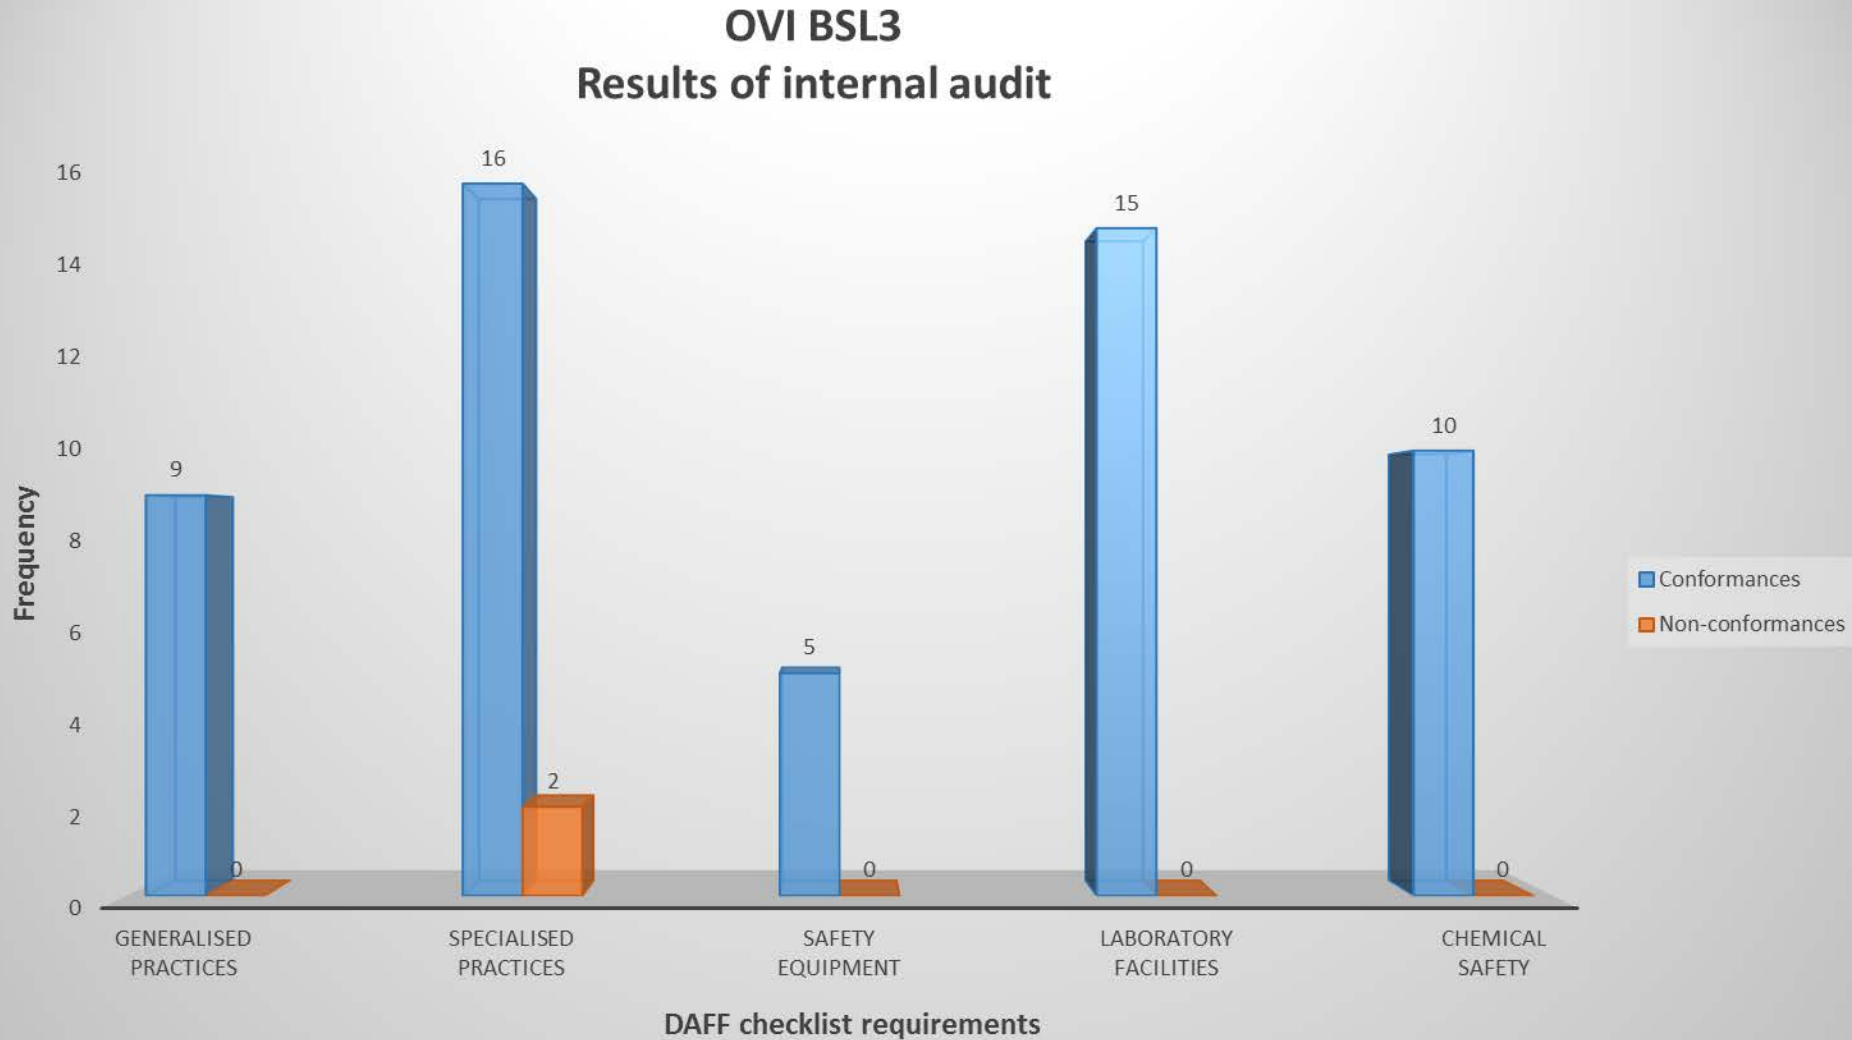
Figure 1: Results of the internal audit
