# Seriously, an insectary at a primate center?

Kalpana Patel, RBP and Maureen Thompson, RN, BSN, COHNs, RBP

Yerkes National Primate Research Center, Emory University

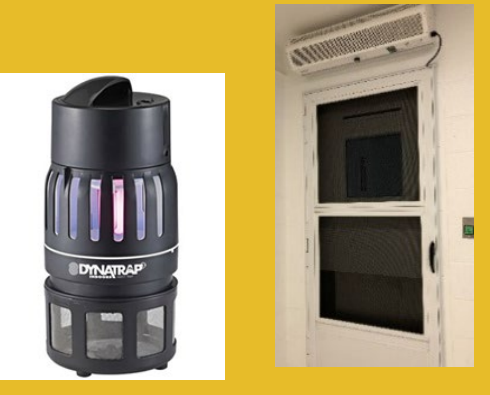
**Mosquito Control**

- Double door entry
- Air Curtains
- Screened door
- Mesh on vents

- Dynotraps
- Zappers
- Pest control

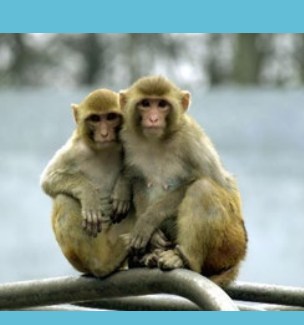
**Construction Concerns**

- Wall to separate from NHP
- Increase monitoring of animal stress
- Additional enrichment provided

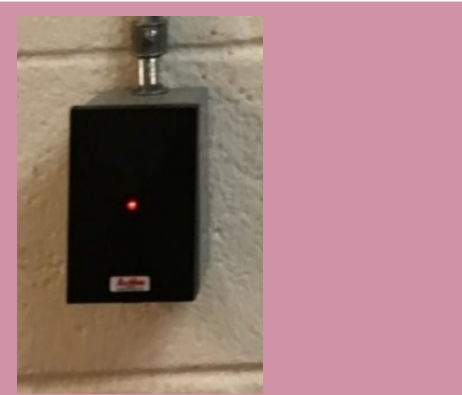
**Security**

- at entry
- to feeding room
- to rearing room

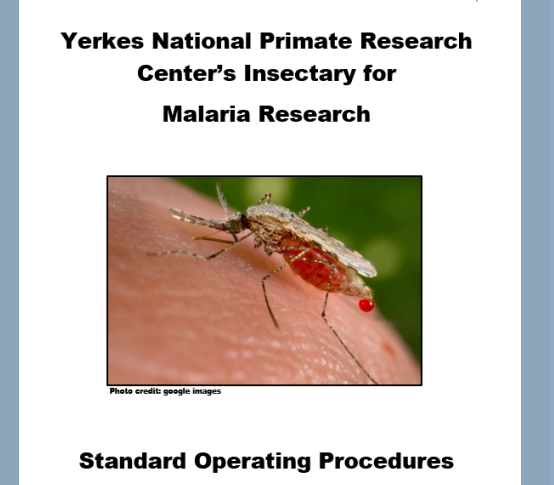
**SOPs**

The risk assessment process was used again to develop standard operating procedures, determine personal protective equipment, and training requirements. (see Fig. 5)
