CENTRIFUGE BIOSAFETY IN BL2 RESEARCH LABORATORIES & UPGRADES – CASE STUDY

David M. Ndegwa, Karen B. Byers and Melissa McCullough
 Dana-Farber Cancer Institute, Boston MA, USA

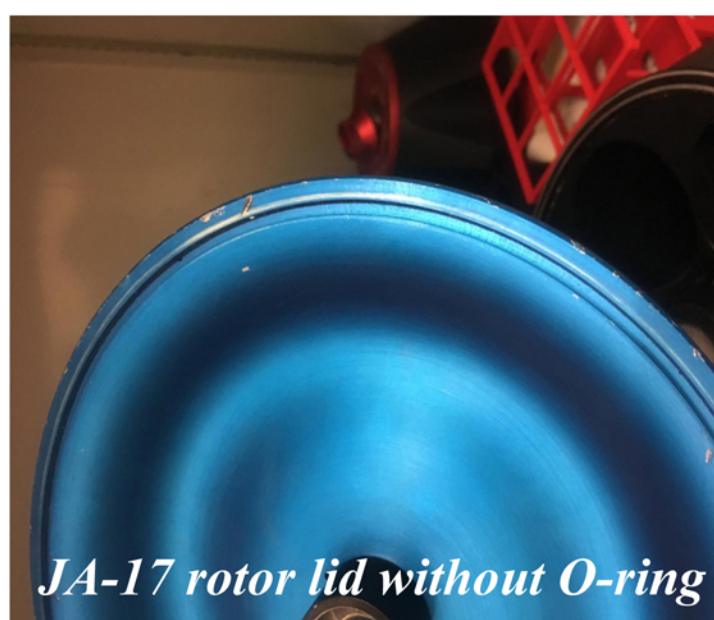
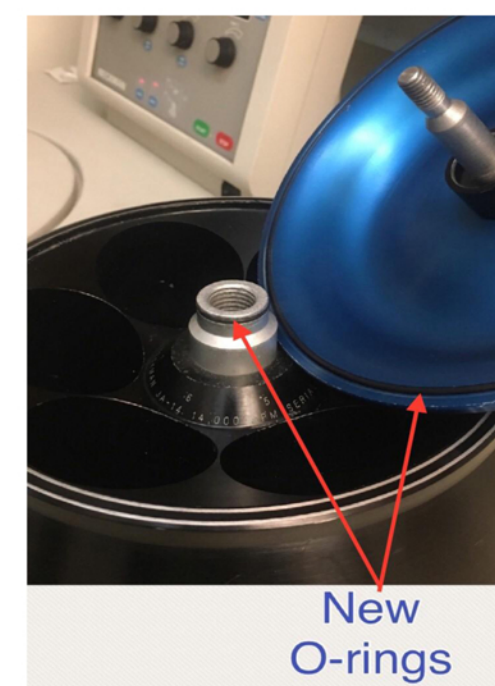
Out of 145 centrifuges, 71 required bucket covers, gaskets (O-rings) or lid support repairs. Supplies were delivered and training provided to laboratory staff at that time. Stickers were applied to centrifuge lids to reinforce of proper practice. Unexpected findings included discovery of an obsolete centrifuge with no safety engineering. The unit was immediately confiscated and a new replacement centrifuge ordered. Two centrifuges had defective lid hydraulic support arms and were located under shelves so the lid could not be opened completely. These support arms were replaced and either the shelf above was removed or the table was lowered.
