Case Study – Decontamination of a PC2 Cell Culture Laboratory in a University setting.

COMMERCIAL
POSTER

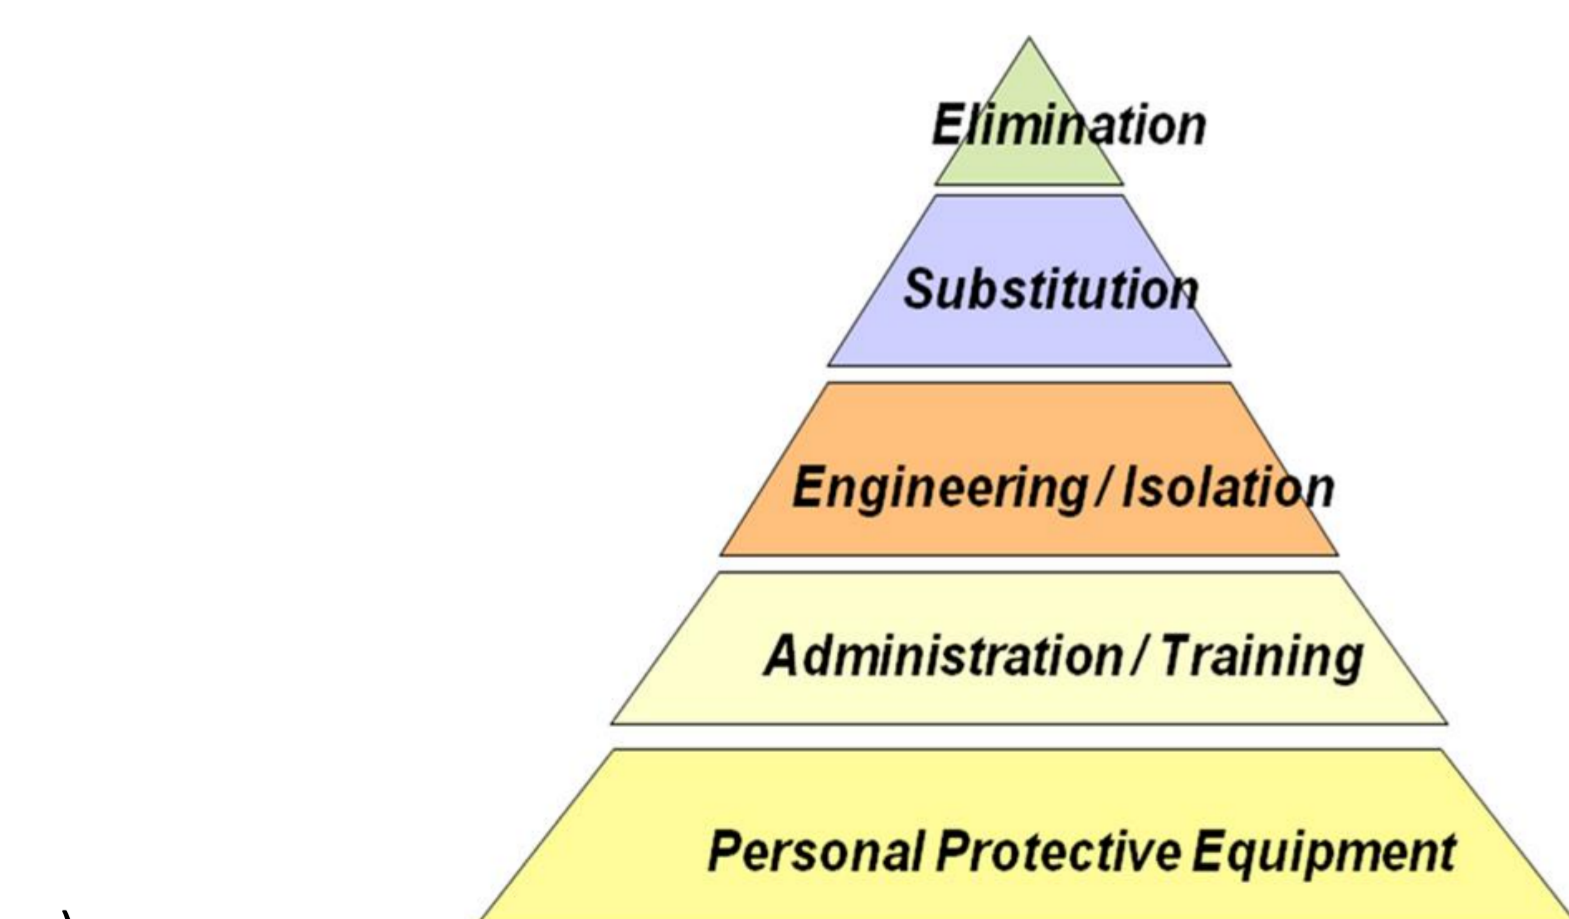
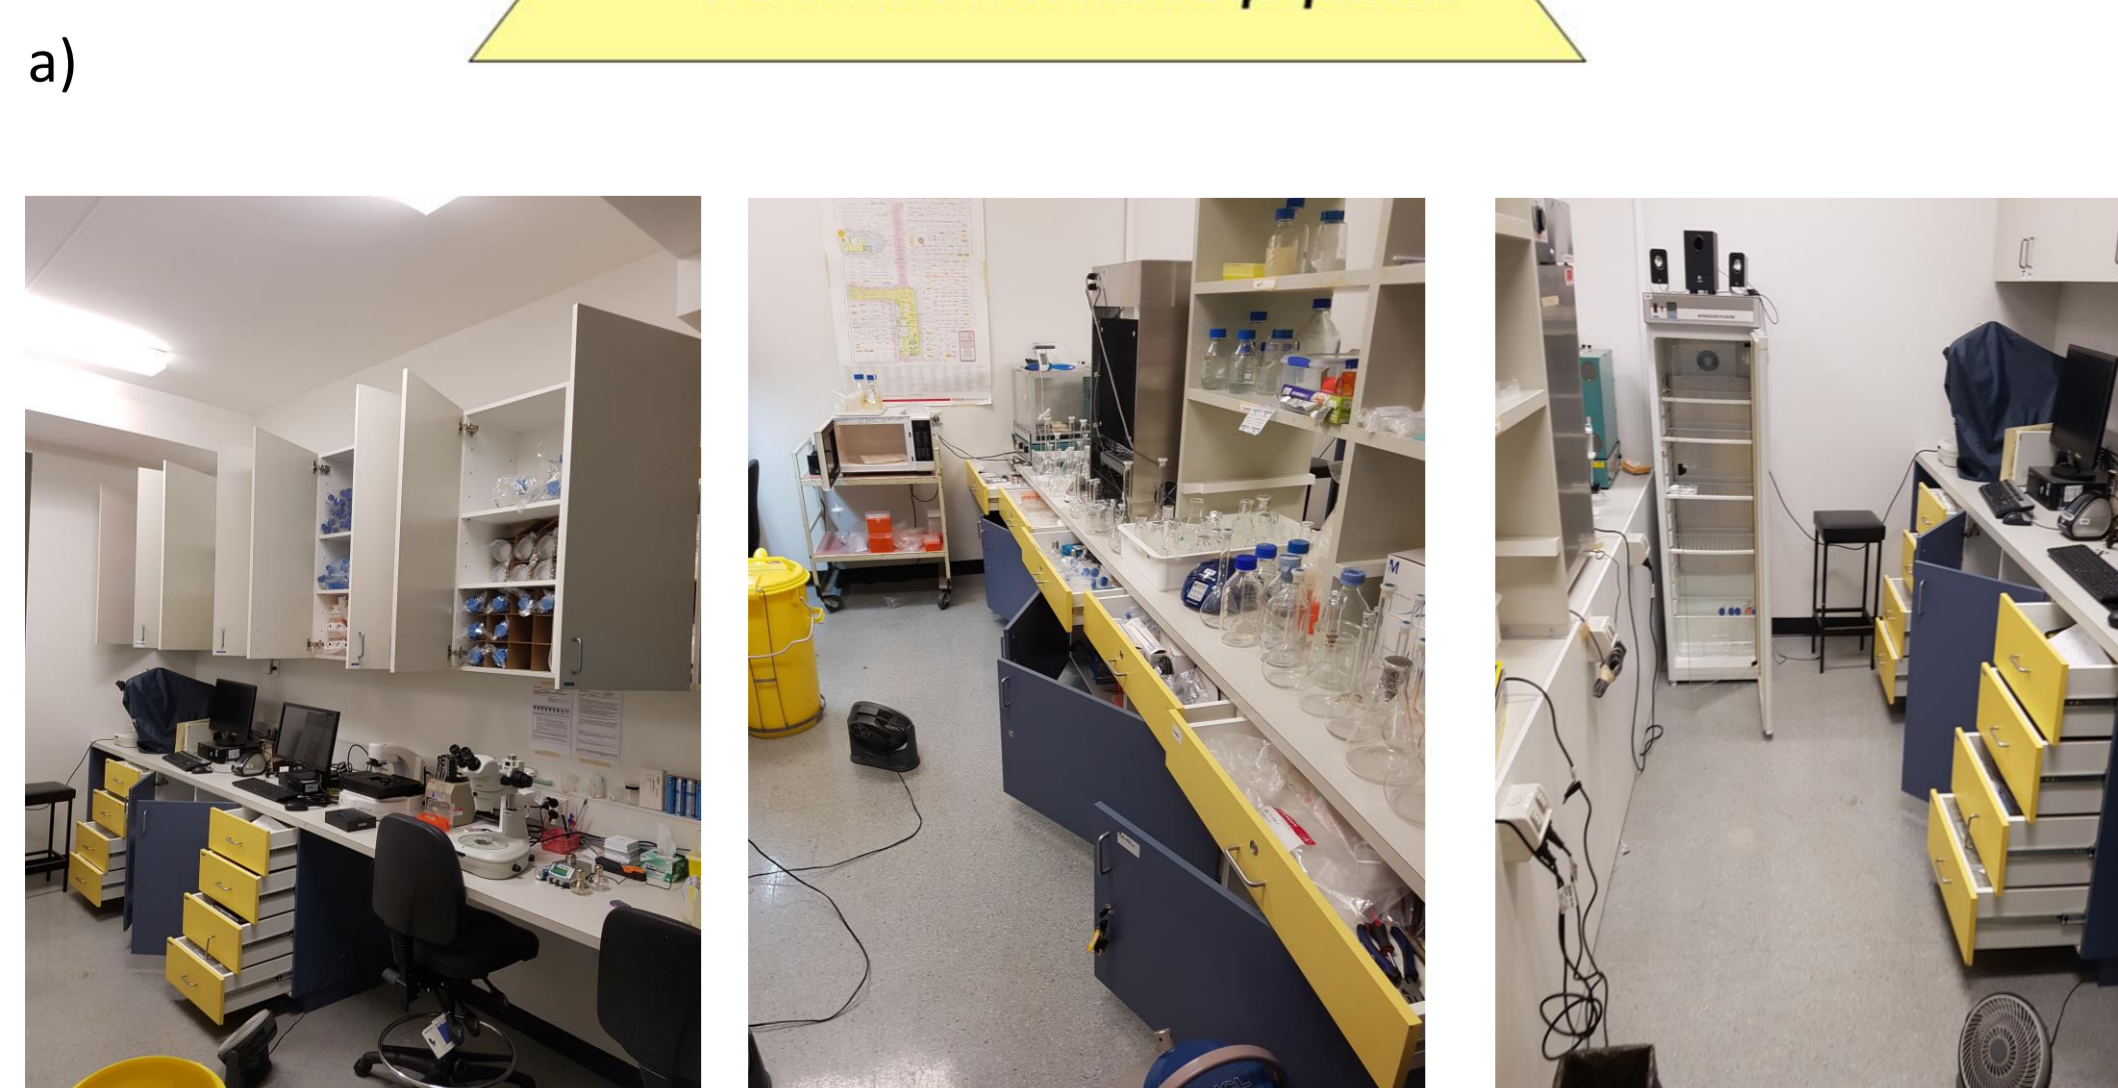
Figure 1.1 a) The hierarchy of controls
b) Images of the inside of the PC2 Cell Culture Facility.

Following the hierarchy of controls (see Figure 1.1), the potential source of contamination was investigated, the facility was isolated and work ceased as a precaution. The room was isolated and live cell cultures were stored in two incubators. The challenge here was that these live cultures had to remain in the incubators whilst the hygiene works were conducted. This meant that they had to be isolated in the space during the gassing phase of the project.

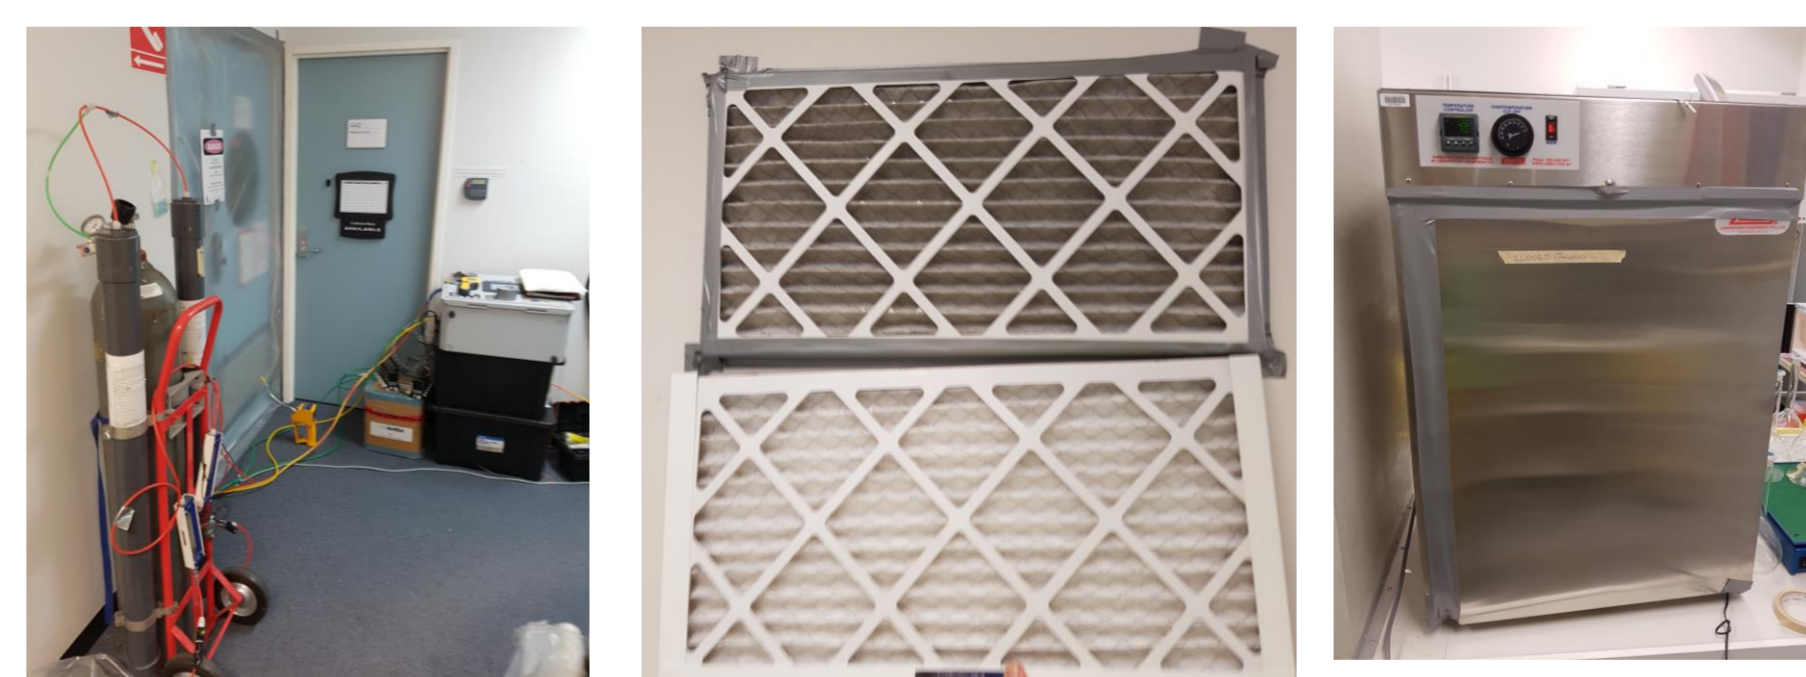
Figure 1.3 – The Cell culture laboratory after setup for fumigation had been completed. The air filter fitted on the supply air can be seen in the centre with the filter after 1 week operation. The sealed incubator containing live cultures can be seen on the left.

The process of fumigation could then be carried out in a time efficient manner. Once technicians had arrived on site, the process of preparing the laboratory began immediately with the relative humidity of the lab being raised to between 65%-75% and fans being laid out to ensure even dispersal of the ClO₂ gas. As the HVAC system could not be used in this instance to safely purge the Laboratory of Chlorine Dioxide, carbon scrubbers were setup within the room and in a manner which allowed them to be externally activated when required.

During the packing down process of the decontamination cycle, a new pre-filter was placed over the HVAC supply air grill, which had been determined as a probable source of contamination. After a period of a week the temporary fixture was removed with a more permanent housing for the filter being put into place. Over the duration of a week there were significant levels of particulate build up on the filter which suggested that it was highly likely that this was a source of contamination within the laboratory.
