Addressing Unique Challenges Influencing Contamination Control of Common Biocontainment Enclosures

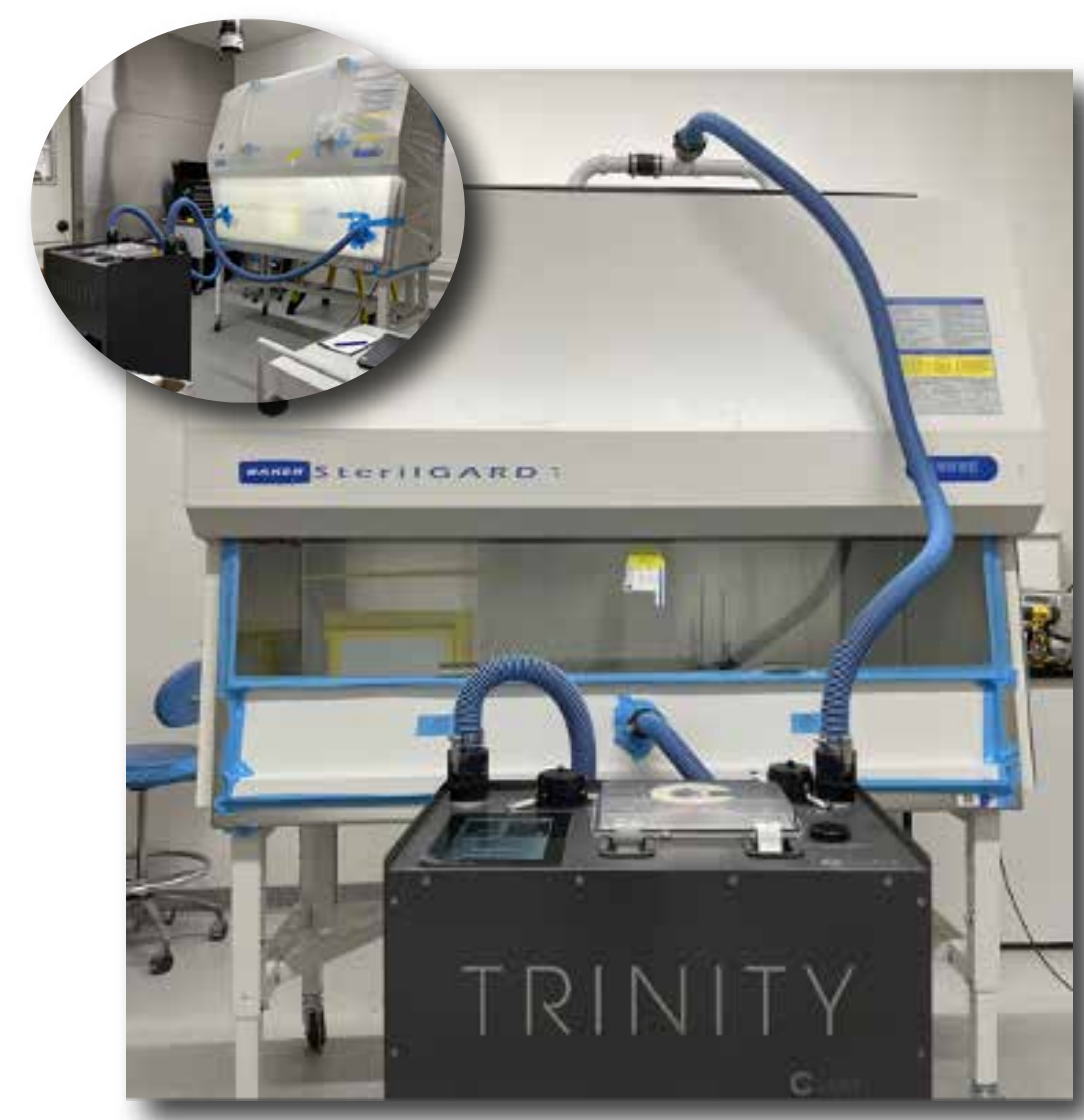
Biological Safety Cabinets

Efficacy was tested throughout the various brands and sizes of BSCs noted in the table below. Biodecontamination of each BSC was tested via two different methods of sealing—tenting and taping. For each test, BIs and CIs were placed in the following locations:

- On the Work Surface
- Under the Work Surface
- Filters and Plenum
- NSF Standard Locations

Manufacturer	BSC Sizes	Total # Tests	Total # BIs	# BIs Passed	# BIs Failed
NuAire	3 Taping	27	27	27	0
	3 Tenting	27	27	27	0
	3 Taping	27	27	27	0
Germfree	4' cGMP Class II A2	27	27	27	0
	3 Taping	27	27	27	0
	3 Taping	27	27	27	0
Baker	4' Class II A2	6 Taping	51	51	0
	SterilGARD (2 BSCs)	10 Tenting	91	91	0
		2 Taping	24	23	1*
	6' Class II A2 SterilGARD	2 Tenting	24	24	0
Total Overall		277	277	277	1

*BI was placed on Control Panel, which was not in the field of decontamination; therefore, a failure was to be expected.

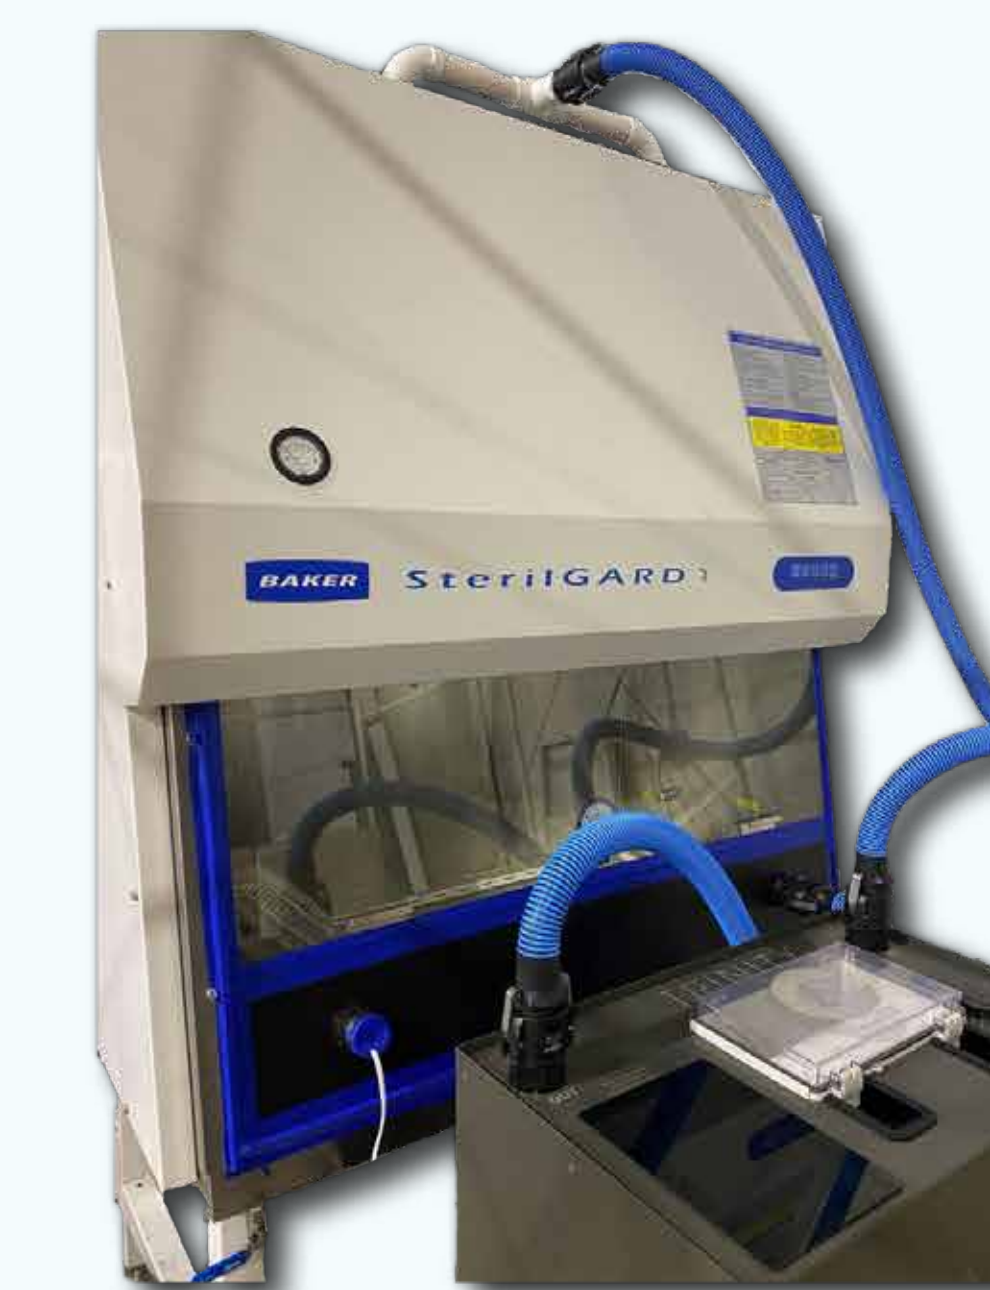
No Blower BSC Decon

Occasionally, a BSC blower may be inoperable, necessitating service; however, the BSC and filters ideally should be decontaminated prior to maintenance to prevent contamination and health risks to staff. Three validation tests using BIs were performed with the addition of a simple desk fan, and results were recorded.

# of Tests	# of BIs	BI Results	
		Pass	Fail
3	21	(All)	0
